Manchester Riverwalk Pedestrian Bridge

UVM CE186 Capstone Design Project
Final Submission
Instructor: Professor John Lens

Re: *Manchester Riverwalk* with UVM CEE Senior Capstone Design Final Design Report

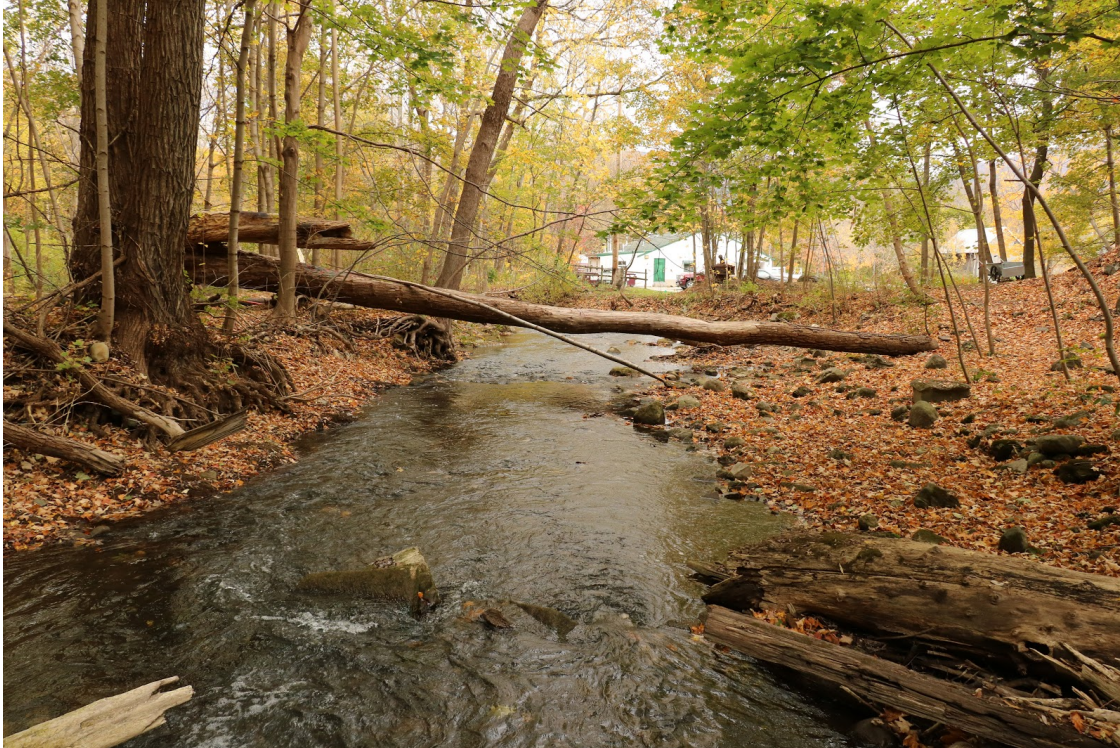
Figure 2: Upstream View of Site Location

Below, Figure 2 shows the upstream view of the site location looking downstream to our site, note the fallen tree currently being used as the river crossing. The site itself will require some maintenance before any construction can occur. Our recommendation is to thin out some of the fallen-in, smaller trees that are close to the site location. These cause potential hazards for the bridge in future years, as the trees grow and get larger, they could fall over (like the one seen in this picture) and destroy the bridge.

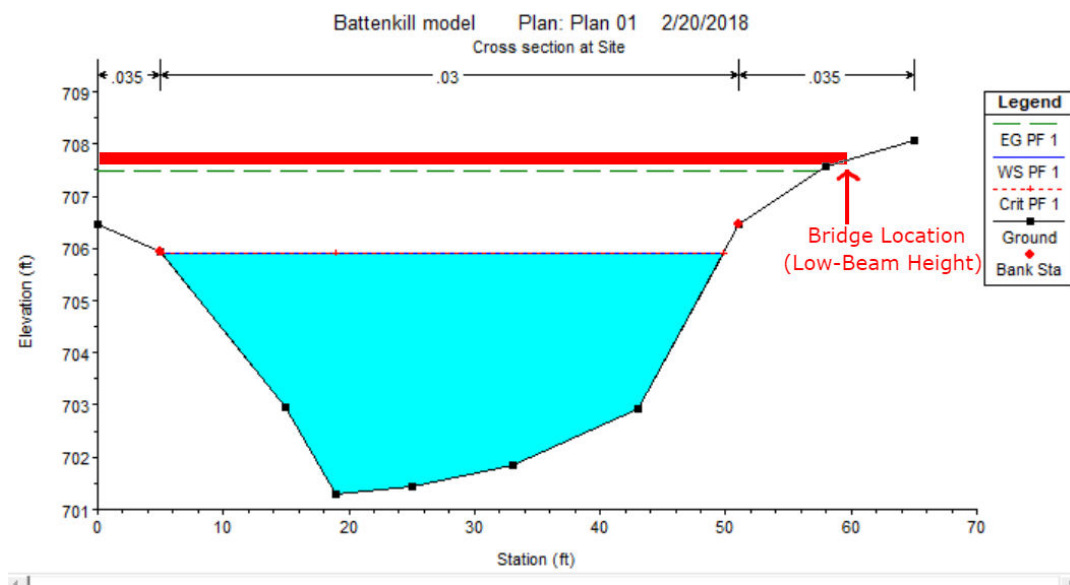
Figure 4: Cross-section at bridge site with water and low-beam elevations

Collected hydraulic data was uploaded to the hydraulic modeling program, HEC-RAS, which calculates the elevation of water after a 10-year storm, per the Town of Manchester standards. The program also shows the water elevation in relation to the low-beam elevation of the bridge and will describe if the structure tops out or not. A structure tops out of the water becomes higher than the structure. In the Hydraulic calculations portion of this deliverable, the charts and figures created by HEC-RAS are shown. From the model, our bridge is required to have a low beam elevation of at least 6-ft. Due to this restrictive height, an arched bridge would be an ideal design for this location. The cross-sectional area under an arched bridge is larger than a simple-span which allows for higher flow during snowmelt season and more debris to flow under the bridge which decreases the risk of damming and flooding. Figure 4 below represents the depth of water after a 10-year storm in relation to the low-beam height of the bridge.

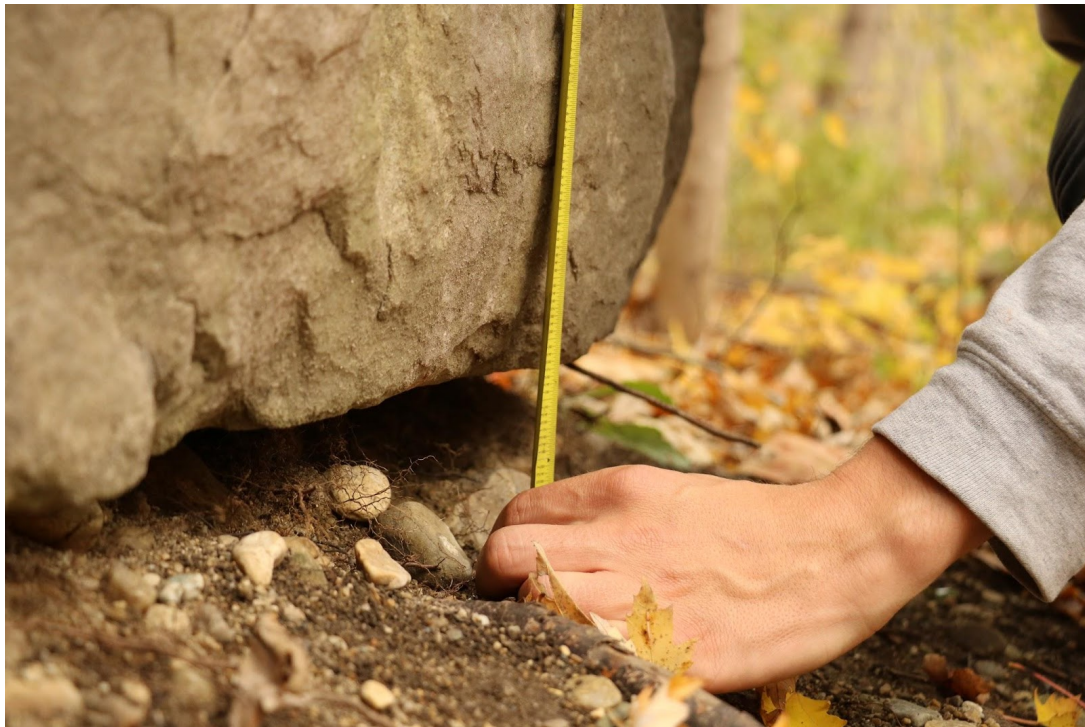
Figure 5: Scour present on the current abutments

During site visits, approximately 4-inches of scour was measured on each existing abutment as seen in Figure 5 below. Our team also expressed concerns with the instability of the failing slope on the left side of our site, as well as the banks adjacent to buildings further upstream, but this was not in the scope of our project to be addressed. The remnants of the previously demolished bridge are currently in the floodplain, and to meet regulations of no net fill requirements.

Although, we believe from our subsurface exploration that bedrock is less than 5-ft below surface level, we have incorporated scour prevention methods to ensure the new abutments will not be as susceptible to scour as the old ones were. The scouring tactic will be to place about a 6-inch thick layer of $\frac{3}{4}$ ” crushed gravel at the bottom of the trench dug for each abutment. We believe our foundation design to be of the utmost quality in providing safety and serviceability to our bridge.

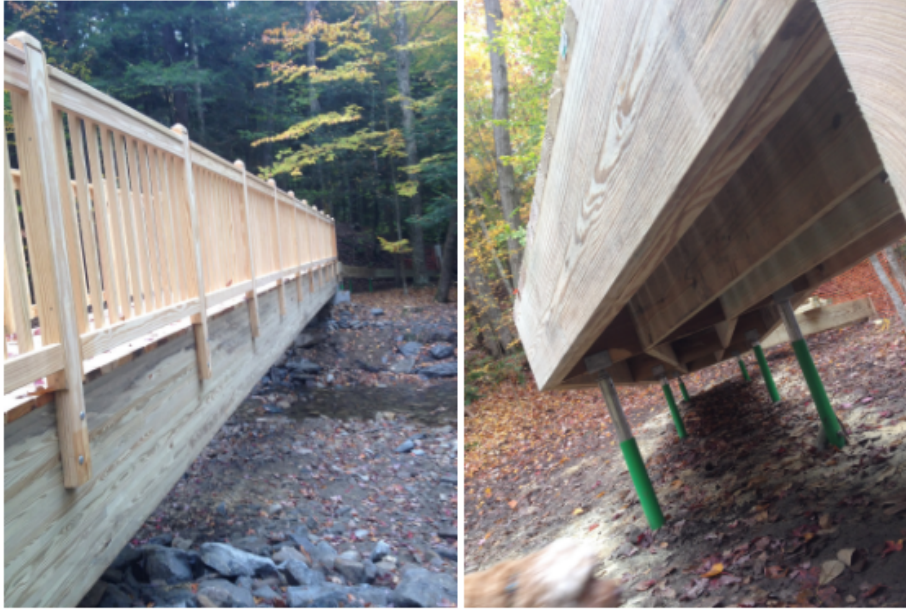
Figure 7: Hapgood Pond “floating” bridge structure (left) and adjustable sleeve piles supporting the structure (right) (Photo property of Ken Allard)

This design alternative will be the most expensive for the MRC but meets their desire for a bridge. As said before, this site is very susceptible to flooding. A floatable bridge is a feasible option for a footbridge at this location because the pile sleeves allow for a sturdy support for the structure while allowing the bridge to translate vertically in the event of severe flooding. The piles (similar to Hapgood Pond, in Figure 7) are expected to be driven outside of the channel but within the floodplain.

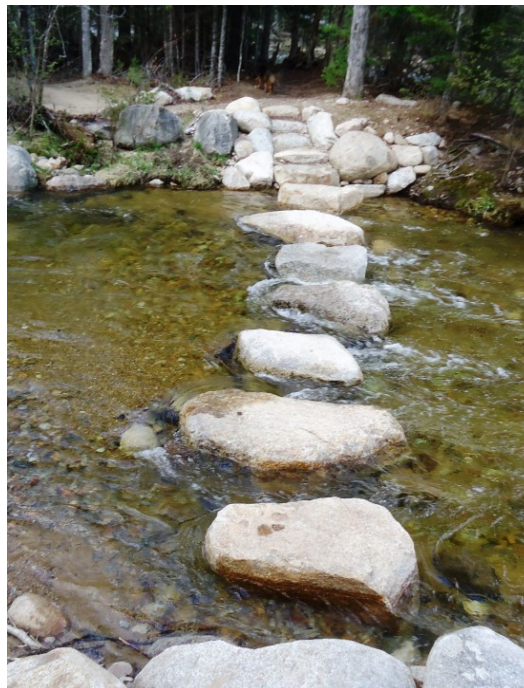
Figure 8: Mad River Path River Crossing (Source: <http://www.wvnh.com/mad-river-stepping-stones/>)

The biggest design challenge posed with the stepping stone path is damming of sediment, flow, and any aquatic wildlife. The stepping stone crossing adds a dynamic feeling to the riverwalk and allows a greater capacity for this trail to become a park that feels alive. A full analysis of the stepping stone design implemented in the Manchester Riverwalk will be evaluated in hydraulic software to ensure any structure is capable of passing sediment and debris. The stream crossing structure would be similar to Figure 8 below located at Mad River Path River Crossing.

The rock stream crossing along the river bed is the least technically challenging option out of the possible designs we have come up with, besides the 'Do Nothing' approach. However, a stream crossing poses threats to the surrounding ecosystem that we will have to take into consideration. Large rocks that are being placed directly into the stream bed derive problems to change of flow to the river, and pose a threat to native species that may navigate this river. When looking further into the possibility of this design we need to take into consideration the adverse effects it will have on the surrounding environment.

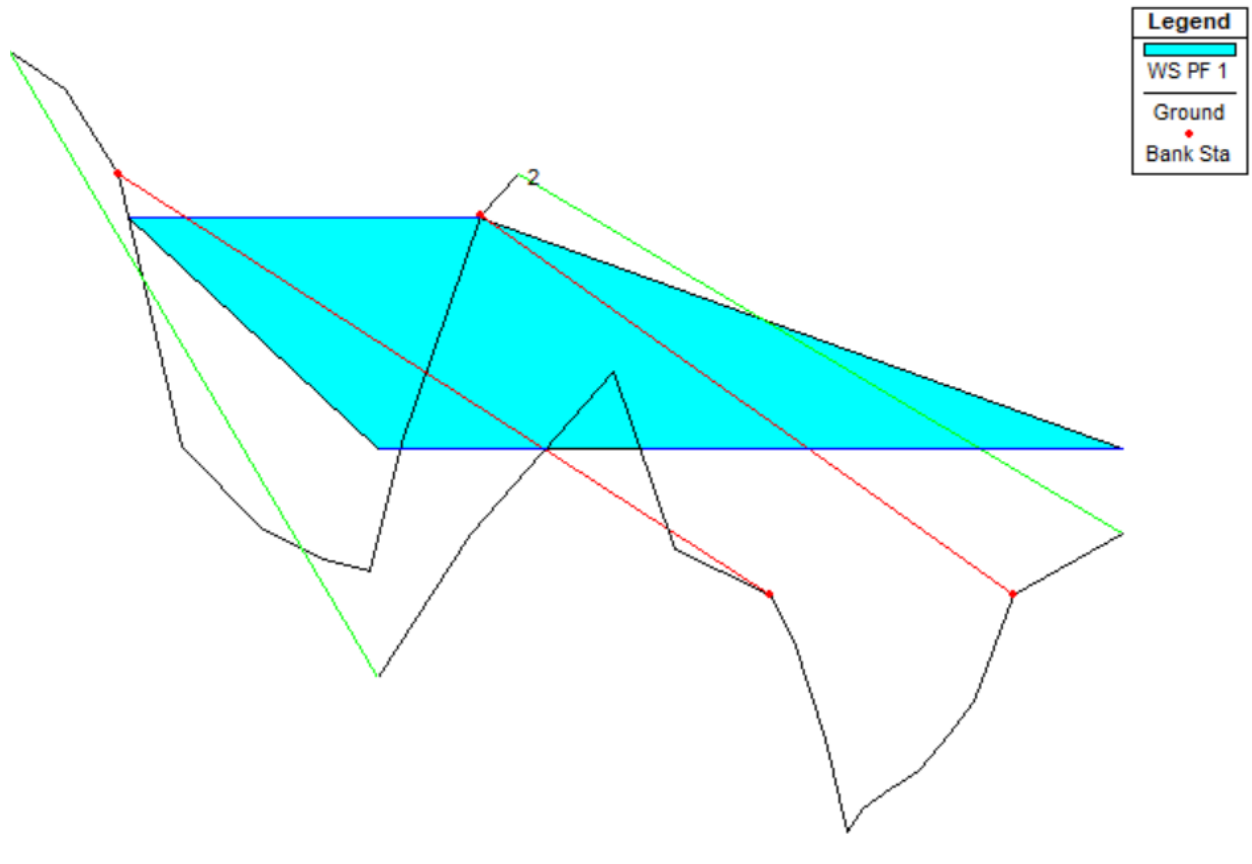
The above image is a three-dimensional model of the Battenkill River between the site of the bridge and 100 feet downstream. The model demonstrates the water elevation in relation to the river cross-sections after a 10-year storm event. The model shows that some of the banks along the river will be overtopped by this storm event, causing water to enter the floodplain.

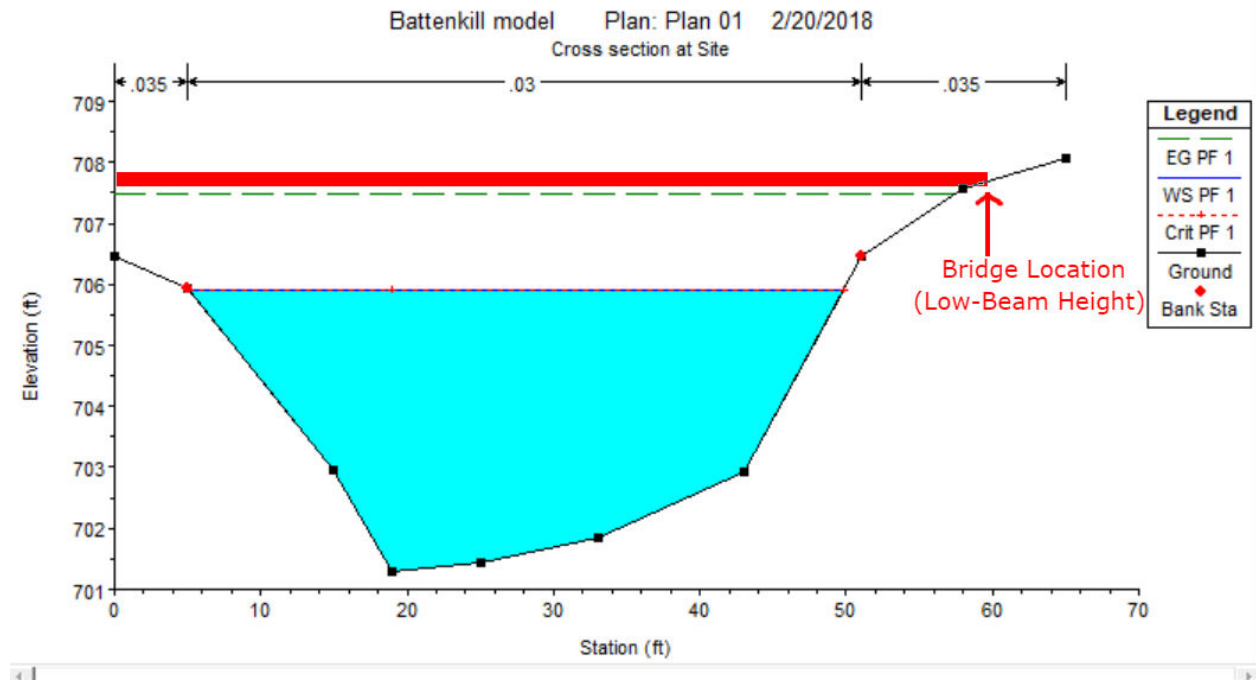
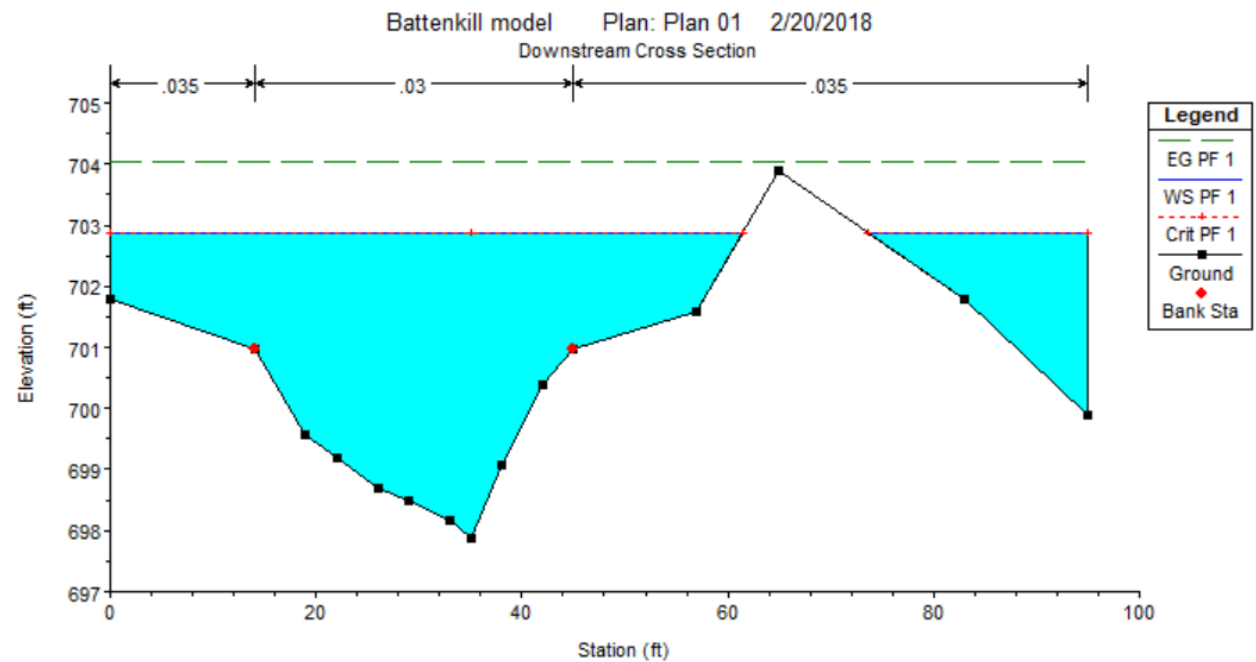
The below image is the cross-section of the riverbed at the location of the bridge. The low-beam height of the bridge is shown by the red line. The blue section represents the depth of water from a 10-year storm event.

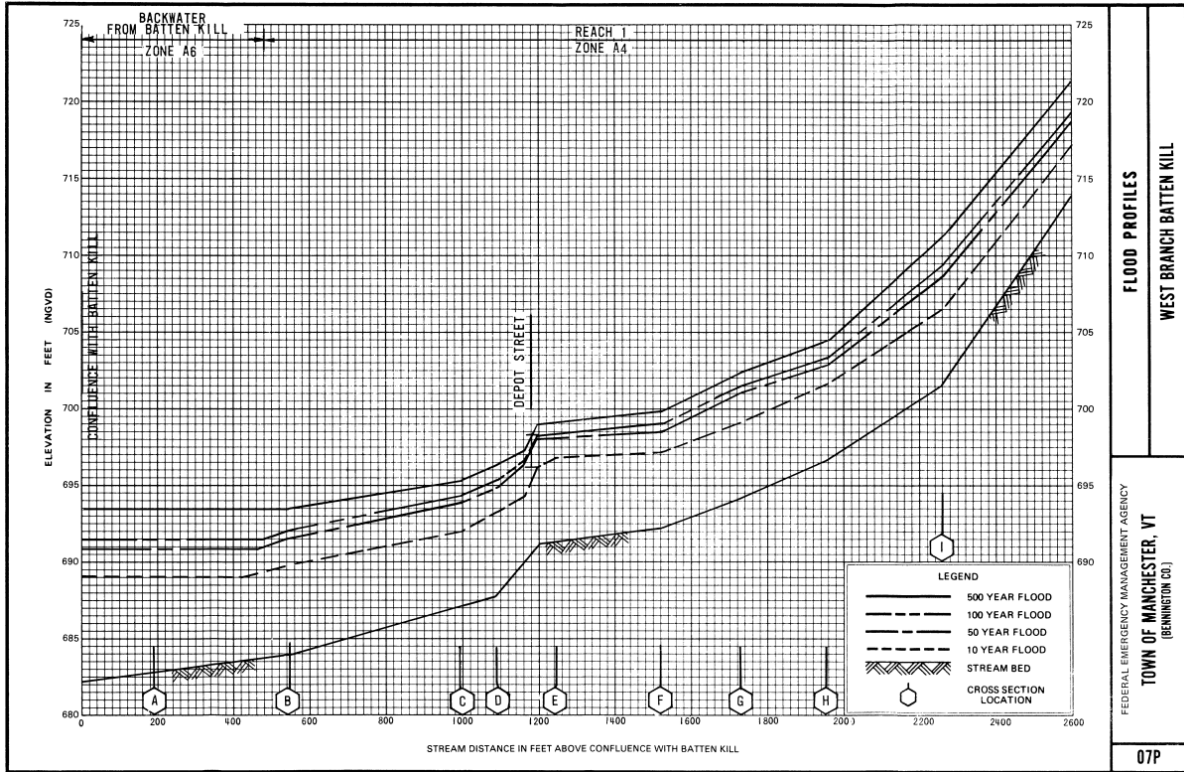
Figure 7: Profile of X-yr Flood Levels on the West Branch of the Battenkill River

Figure 7 shows the data for flood levels for our particular site on the Battenkill River. This data will be useful, again, for designing for a a 100 year flood, to ensure the bridge will hold up under these conditions.

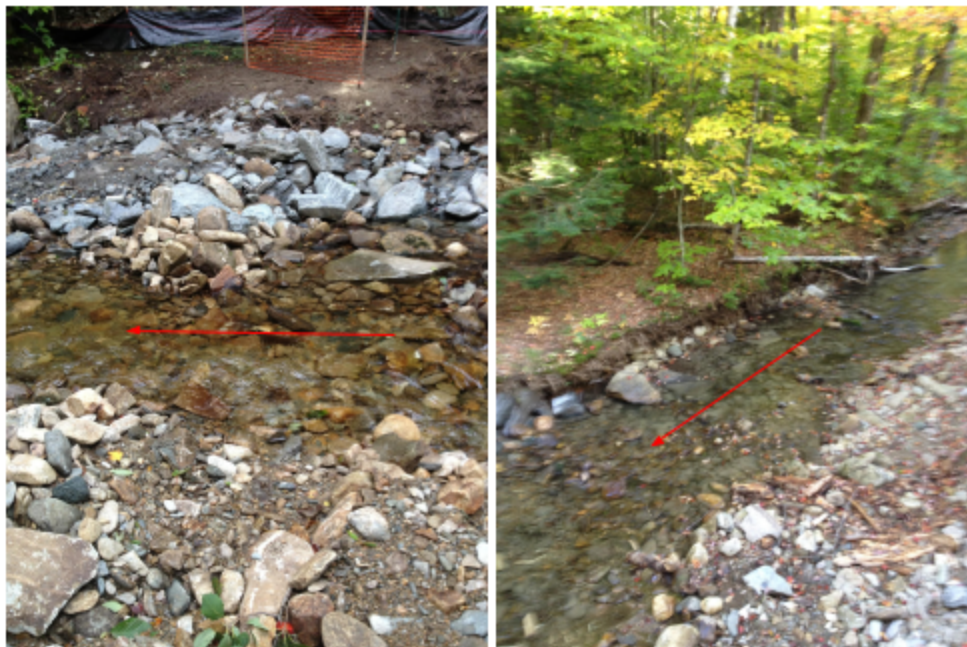
*Figure 15: Hapgood Pond Stream Crossing Location (left) and upstream view of channel width (right)
(Photo property of Ken Allard)*

Hapgood Pond has similar site conditions (see below Figure 15) of a narrow stream channel with a large floodplain. In 2013, a “floating” bridge was implemented at this site (see below Figure 16) using pilings as anchors for the bridge (see below Figure 17). When properly installed, this gives the bridge an excellent chance of staying in place throughout season changes and intense storm conditions.

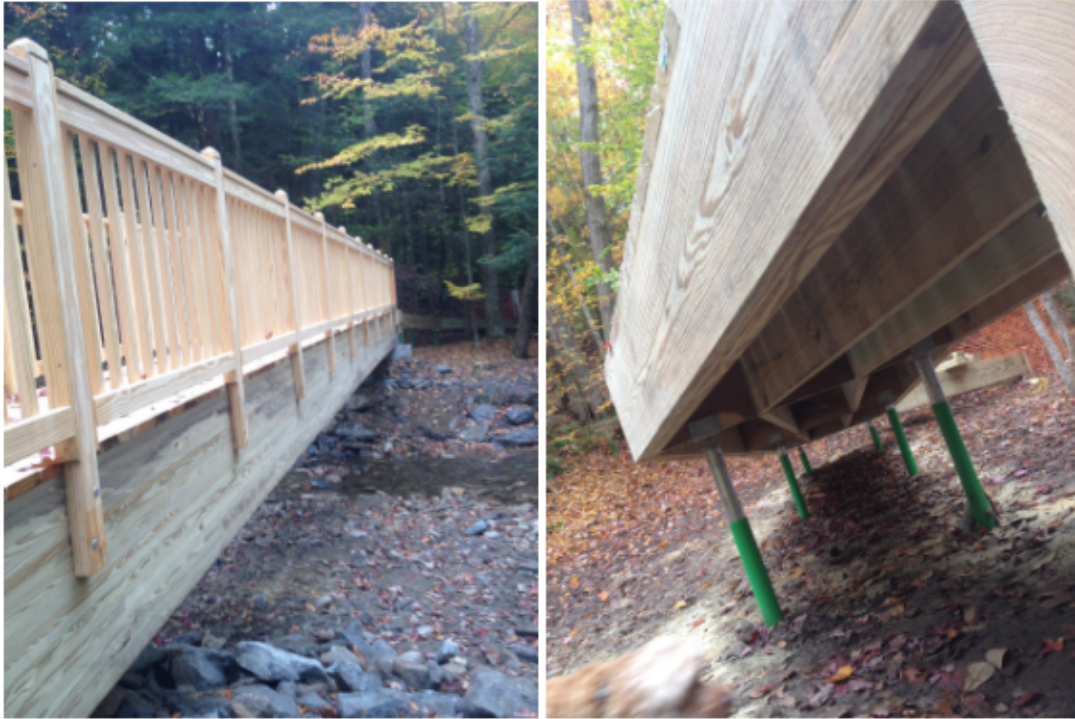
Figure 16: Hapgood Pond replacement, “floating” bridge structure (left) and adjustable sleeve piles supporting the structure (right) (Photo property of Ken Allard)

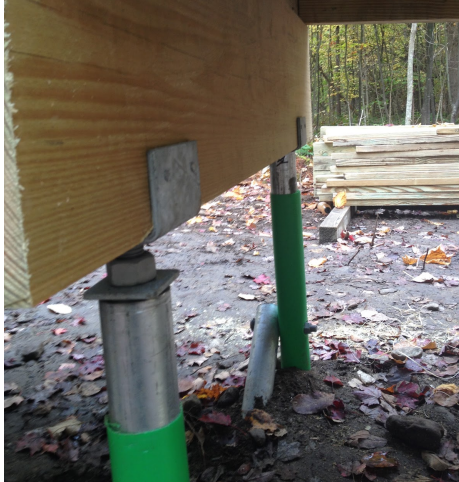
Figure 18: Close-up of pile system: Square plate tops the hollow pile, round pile below anchors the bride (Photo property of Ken Allard)

The way these sleeved piles work is by setting a traditional pile initially and then fitting a hollow pile (with a bearing plate to hold the deck at its normal elevation above the water) over the first pile. As rising water pulls the deck up, the hollow pile will move up with the water and drop back down as the water level recedes. A closer look at the fitting between the two piles is shown in Figure 18 below.

A cable anchorage system is typically used in floating bridge structures but this was not an option for the Manchester Riverwalk project because the cables require adjustments seasonally (or more frequently) especially in areas with fluctuating water levels. This pile system is an excellent means of support for structures in areas where the water levels are fluctuating or are unpredictable because they allow vertical movement while still providing anchorage. Also, the piles reduce the twisting forces on the shore connections (and on connections between sections of floating structure - should we have a flood event where the bride would be floating).

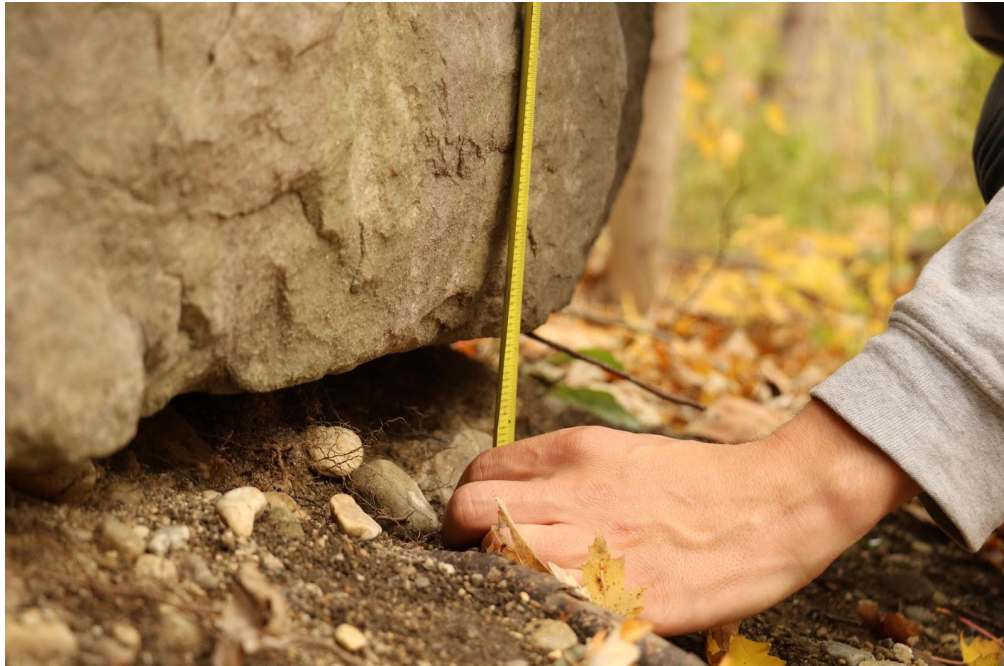
Figure 19: Existing Scour on Abutments

- About 4-inches of existing scour
- Subsurface exploration
 - 0"-6": woodchip fill
 - 6"-12": smaller stone fill, less wood chips
 - 12"-18": very loose gravel
 - 18"-24": larger stones, more dense
- Bedrock was hit with hand auger
 - Hole measured at 20.5"

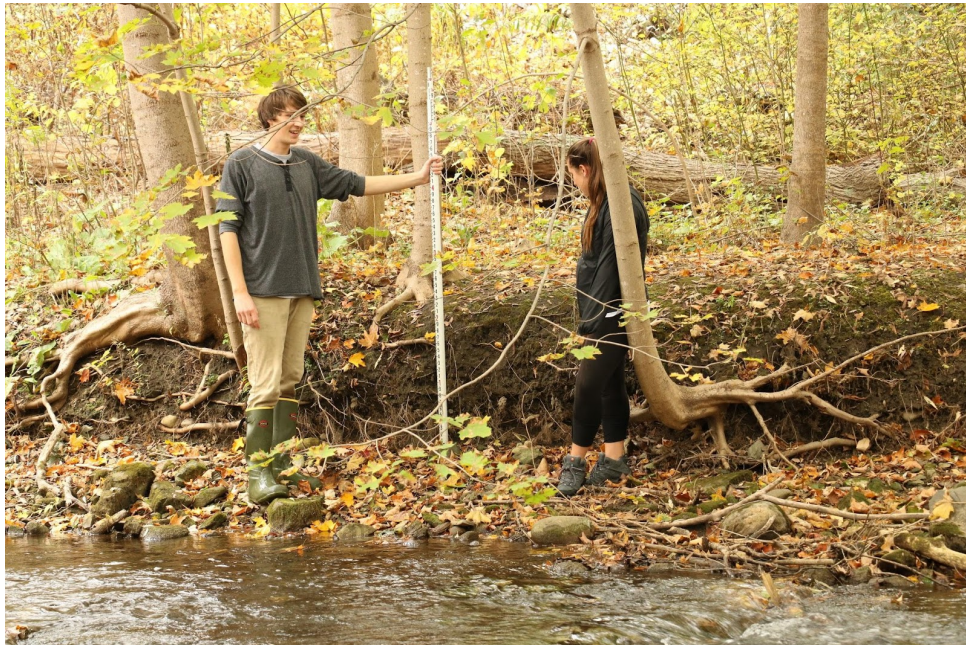
Figure 20: Erosion on the Riverbank with 5' Girl (Kate) for Scale

- Erosion currently about 3-ft high
- Roughly 30-degrees from channel to top of riverbed
- Landslide occurring on left side of river
 - Need some sort of slope stabilization
 - Possible retaining wall

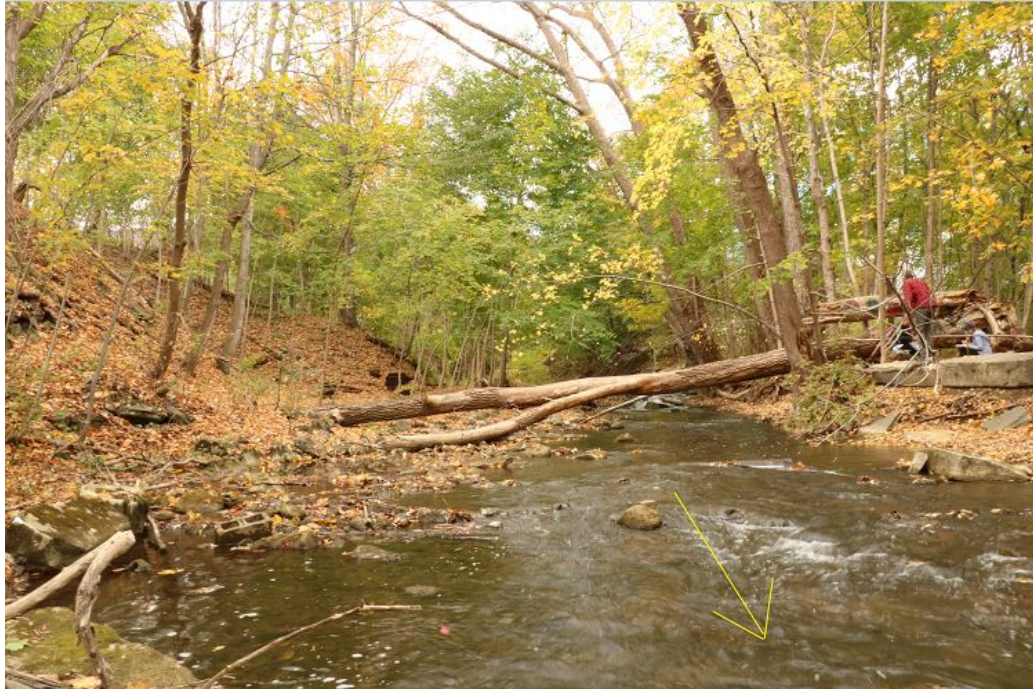
Figure 2. Downstream Cross Section of Stream at Potential Bridge Location

Figure 2 below shows the cross section of the stream that the bridge will likely span. It is important to note that at this location has a change in elevation. This results in a larger flow-rate which creates a higher possibility for scour and incising. These physical changes to the characteristics of the river will have detrimental effects. A river that is incised refers to the eroding of the river bed due to a constriction point that prevents the river from expanding in the horizontal direction; which causes the the turbulence of the river to eat away at the river bed.

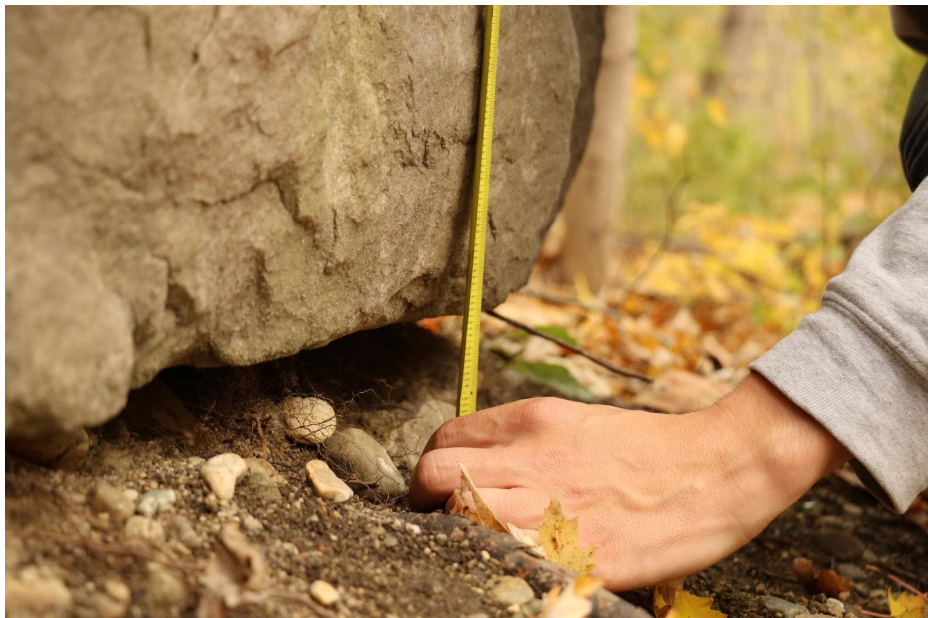
Figure 4. Current Scour on Existing Abutments

Helpful information in regards to geotechnical data is best acquired from professionals that are familiar with the area and the scope of the project. For example, Cassidy Cote, with Vermont Agency of Transportation, visited the site with us to give his expertise. From what he could see, there is work that needs to be done related to the geotechnics of this project. For starters, the abutments are sliding into the river and have about 4 inches of scour (seen in Figure 4); they will have to be completely taken out, the foundation re-dug and re-poured, and then backfilled with gravel material, in order to provide a reliable and safe foundation for the pedestrian bridge.

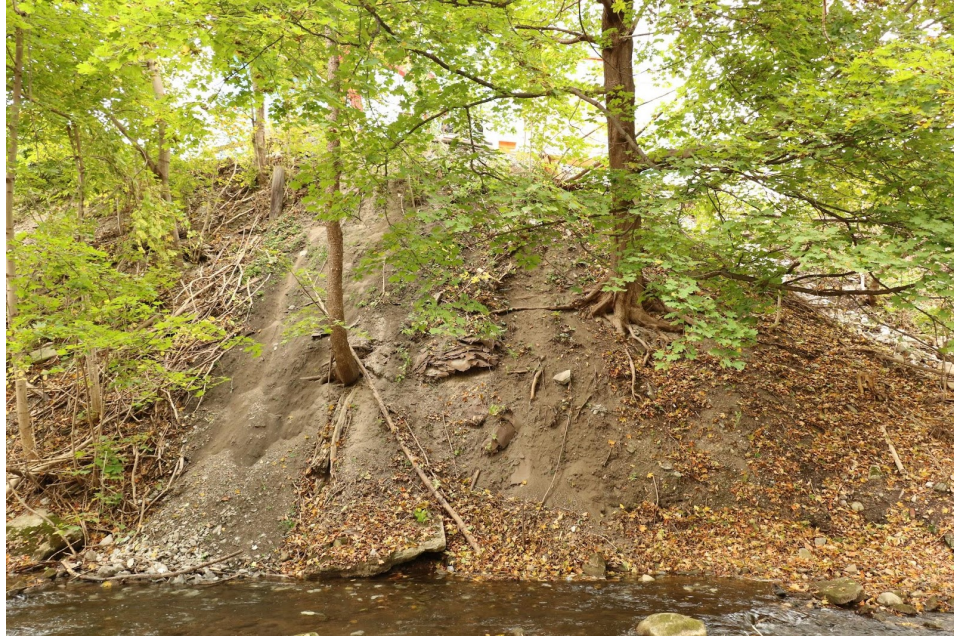
Figure 5. Site of Predicted Landslide

The existing conditions of the site are not up to par with the expected outcome of the project. There are steep banks on either side of the river, one of which on the left side of the river has undergone a landslide already, seen in Figure 5. Cassidy observed the site and said to expect another landslide within the next year, because the fill put into place to stabilize the bank is too small of stones. A volunteer committee organizes this project, where all funds are donated so the budget for this project is minimal, while the work needed is at a maximum.

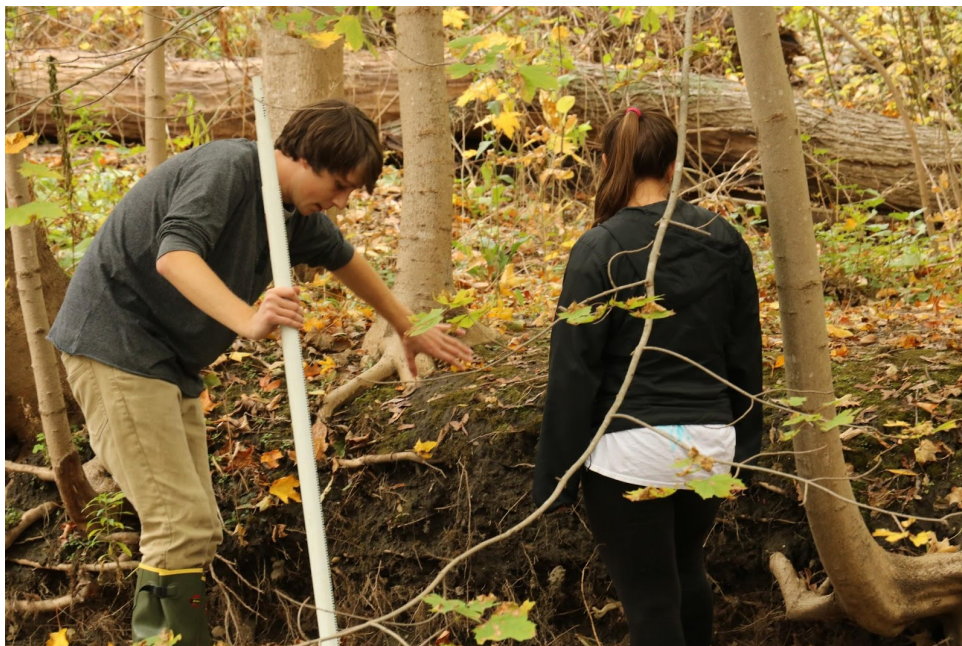
Figure 6. Eroding of the Riverbank.

By observing the site, it is apparent that the river is eating away at the banks, rather than out and flooding the surrounding land. This is not ideal because once it starts eating down vertically it is hard to prevent it from continuing to do so because the exposed soils become more sensitive with rainfall and river flow. According to the [Pedestrian Bridge Design](#) article, to prevent scouring, it is best to put in a deep foundation, which should be done in this case to prevent further eroding and scouring of the abutments. Figure 6 shows the eroding of the riverbank.

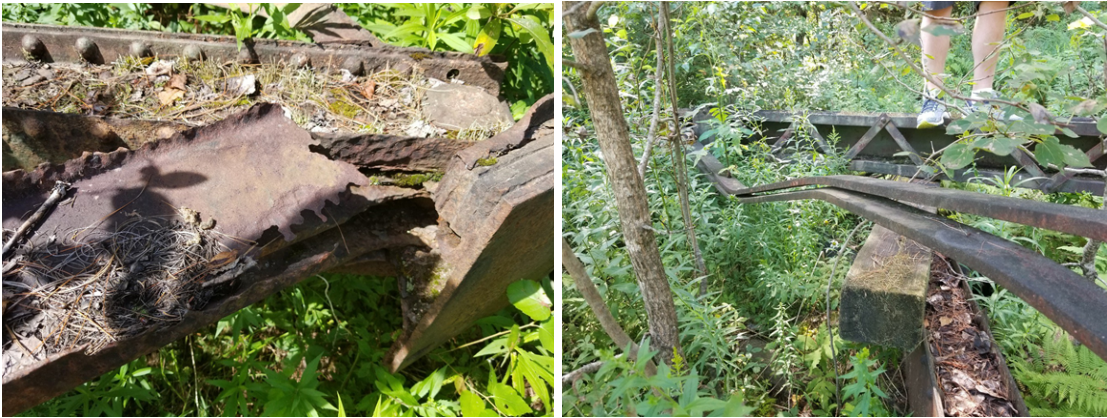
Figure 7. Burke No. 25, 66.5 ft-span

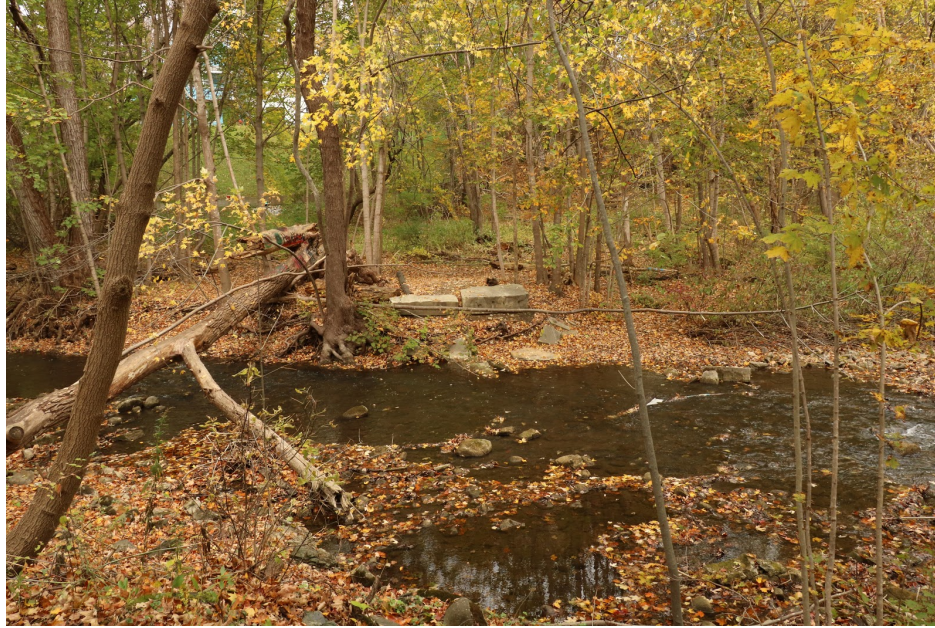
Figure 8. Proposed Bridge Location

Figure 8, below, is the proposed site location for the pedestrian bridge. The fallen tree on the left is the current bridge in use for trail visitors. The marble abutments remain standing on the north side of the river from the previous bridge that was built in the 1970s but was then torn down in the late 1980s. On the north side of the river (far side in Figure 8) the marble abutments could be repurposed aesthetically but cannot be used at the future abutments for the bridge due to erosion problems (scour) and the close proximity of the marble to the steep embankment. On the south side of the river, there are no abutments present and the only sort of stable material are the few large boulders next to riverbank.

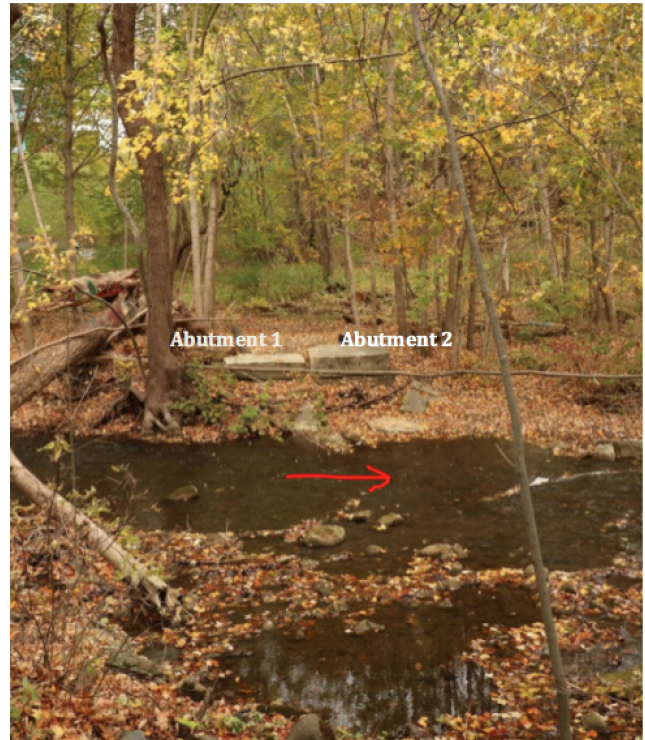
Figure 4: Site Width and Original Abutments

Below, Figure 2 shows the upstream view from the site location, note the narrowness of the river at this location, the river meanders while widening and narrowing downstream. Figures 3 and 4 show the river looking downstream and the width of the river with the existing abutments. This information is important to understanding the hydrology of the river and the flows. Once those are established they will be used to determine the reinforcement at the footings of the bridge. It is also pertinent to mention that upstream about 300-ft, VHB is designing and building a pedestrian bridge to cross from the Factory Point Town Green (seen in Figure 1) to the backside of the Mountain Goat building. Our bridge considerations need to incorporate the thought of another bridge being upstream in order to prevent any flood hazards.

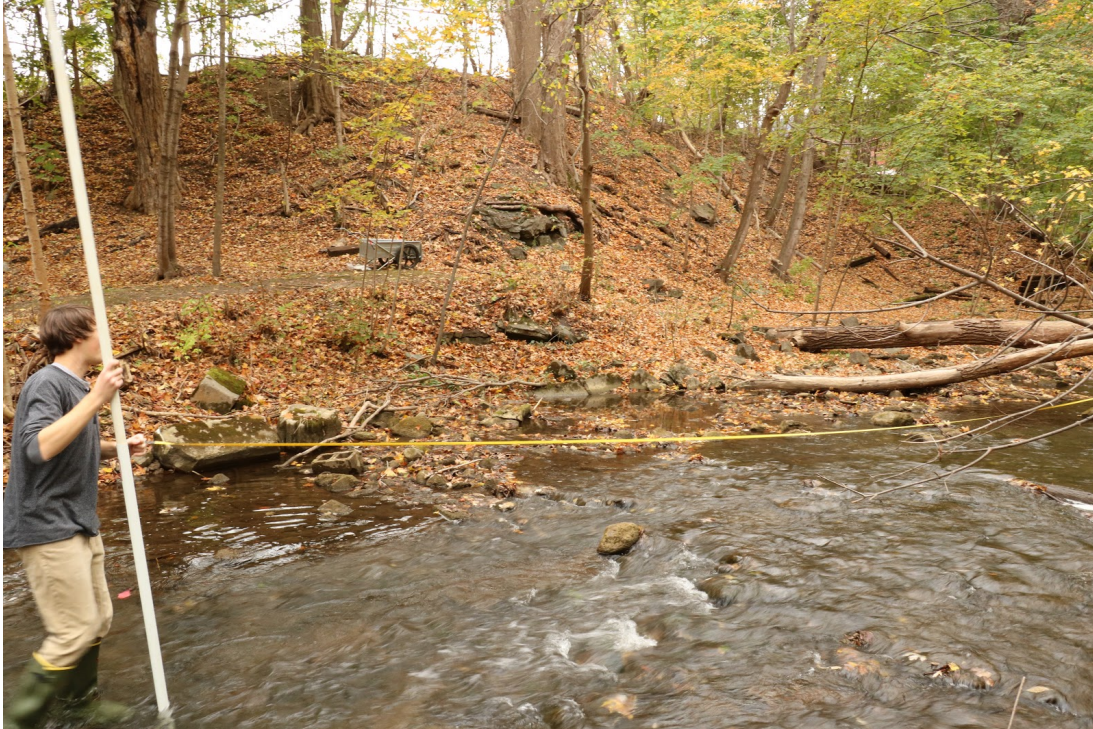
Figure 11: The slope of the land leading up to the site on the south side

Another concern is the feasibility of getting heavy machinery into the site for construction. On either side of the site, there are steep slopes that lead almost all the way to the bridge site. Looking at the current condition, there is only one way into the site with equipment, and that is on the south side. With this issue, some innovative construction is required so that heavy machinery would not be needed. Figure 11 shows the slope that leads up to the bridge location on the south side of the river.

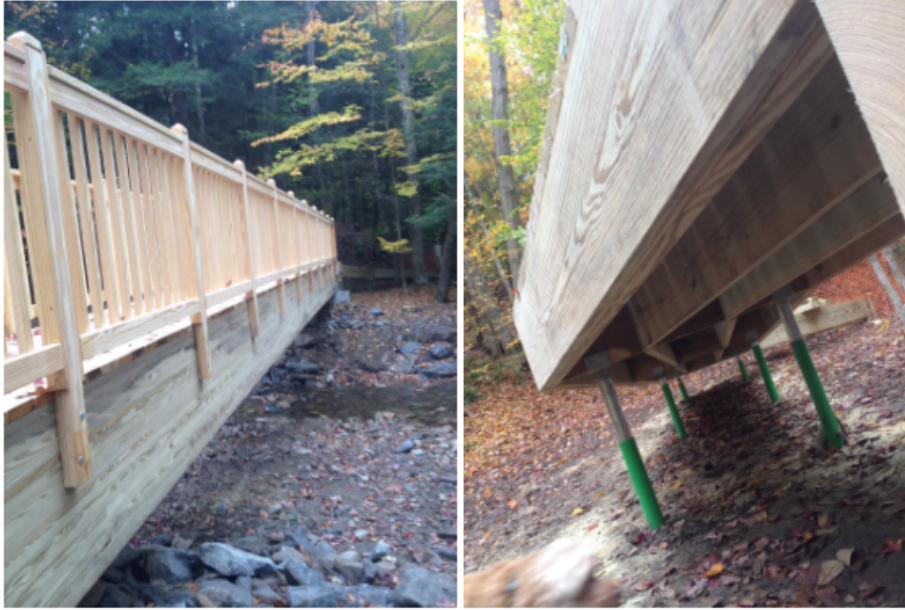
Figure 13: Hapgood Pond “floating” bridge structure (left) and adjustable sleeve piles supporting the structure (right) (Photo property of Ken Allard)

This design alternative will be the most expensive for the MRC but meets their desire for a bridge. As said before, this site is very susceptible to flooding. A floatable bridge is a feasible option for a footbridge at this location because the pile sleeves allow for a sturdy support for the structure while allowing the bridge to translate vertically in the event of severe flooding. The piles (similar to Hapgood Pond, in Figure 13) are expected to be driven outside of the channel but within the floodplain.

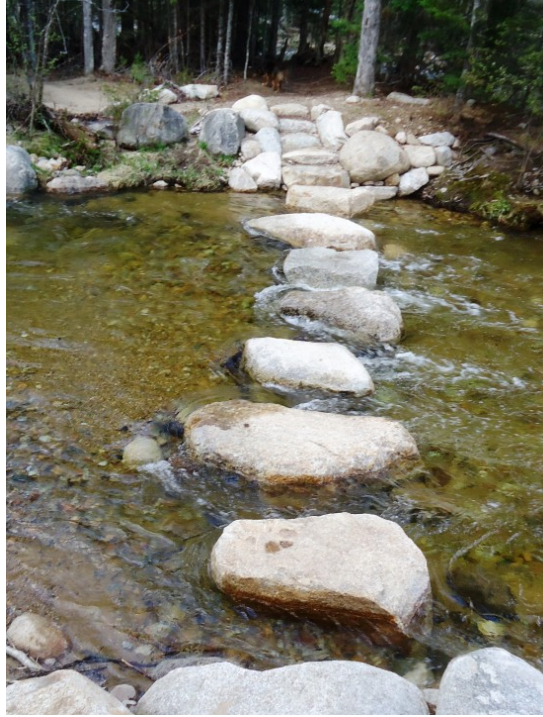
Figure 14: Mad River Path River Crossing (Source: <http://www.wvnh.com/mad-river-stepping-stones/>)

The biggest design challenge posed with the stepping stone path is damming of sediment, flow, and any aquatic wildlife. The stepping stone crossing adds a dynamic feeling to the riverwalk and allows a greater capacity for this trail to become a park that feels alive. A full analysis of the stepping stone design implemented in the Manchester Riverwalk will be evaluated in hydraulic software to ensure any structure is capable of passing sediment and debris. The stream crossing structure would be similar to Figure 14 below located at Mad River Path River Crossing.

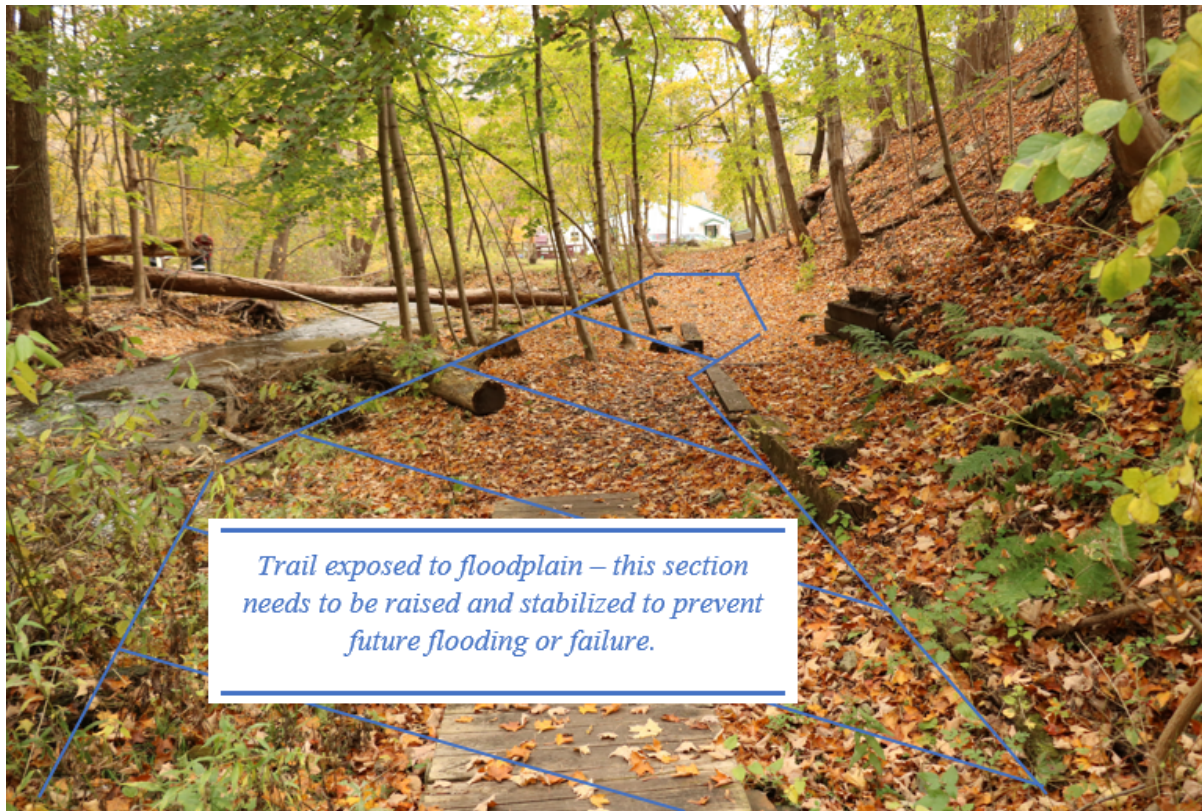
Figure 16: Exposed Trail with Floodplain outlined (blue)

Regardless of a river crossing being implemented at the designated location, there is some serious maintenance that needs to occur at the Manchester Riverwalk. There is excessive debris on and around the trails that needs to be cleaned up, and there are some concerning slope stability issues upstream (between our proposed stream crossing site and the future VHB bridge) that should be addressed. The biggest component to this alternative is modifying the trails on either side of the stream by raising them and adding support so the trail is out of the floodplain. This alternative would only consist of the maintenance required to bring the trail up to a safer standard, with no implementation of a river crossing. In Figure 16 below, all of the current walkways are in danger of flooding again and need to be raised above water level.
